Inspection Report: Hecla Greens Creek Mine

Date of Inspection: Tuesday, November 12, 2013
Date of Report: Monday, November 25, 2013
USDA Forest Service Inspector: David Schmerge

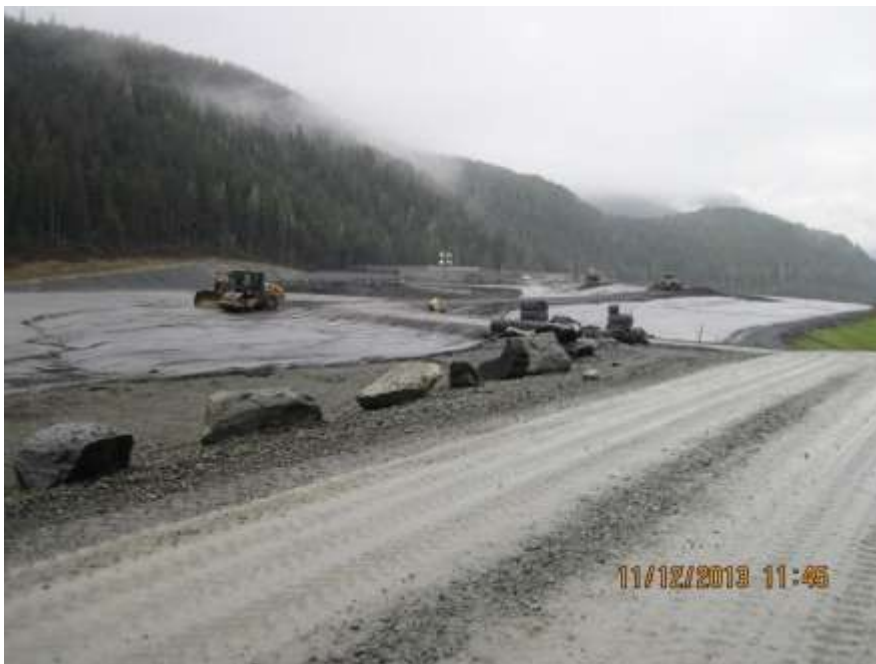
Photo 02. Tailings were being placed in the northwest expansion area on the day of our visit.

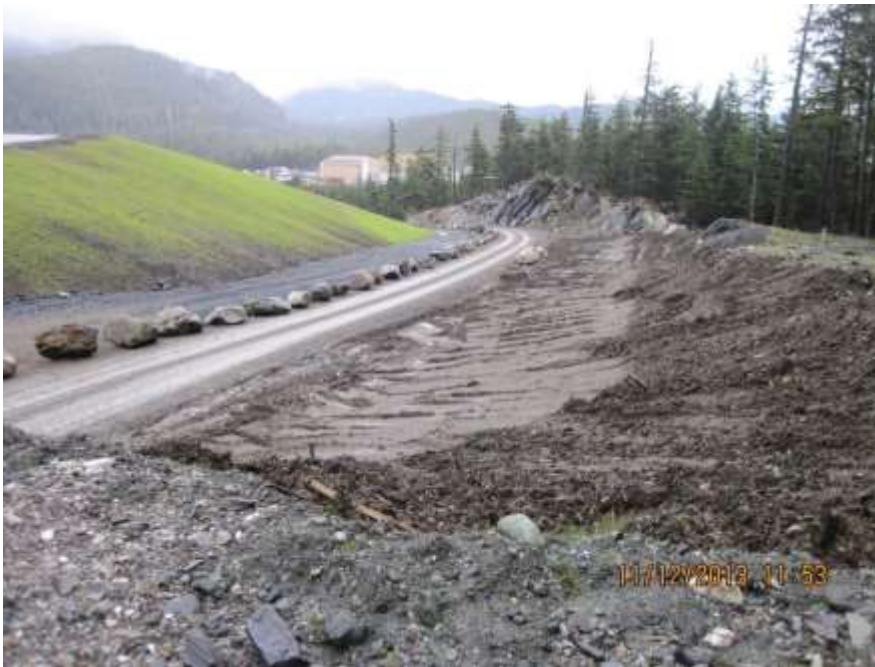
Photo 05. In October, till was placed to seal the west buttress quarry site at the tailings facility.

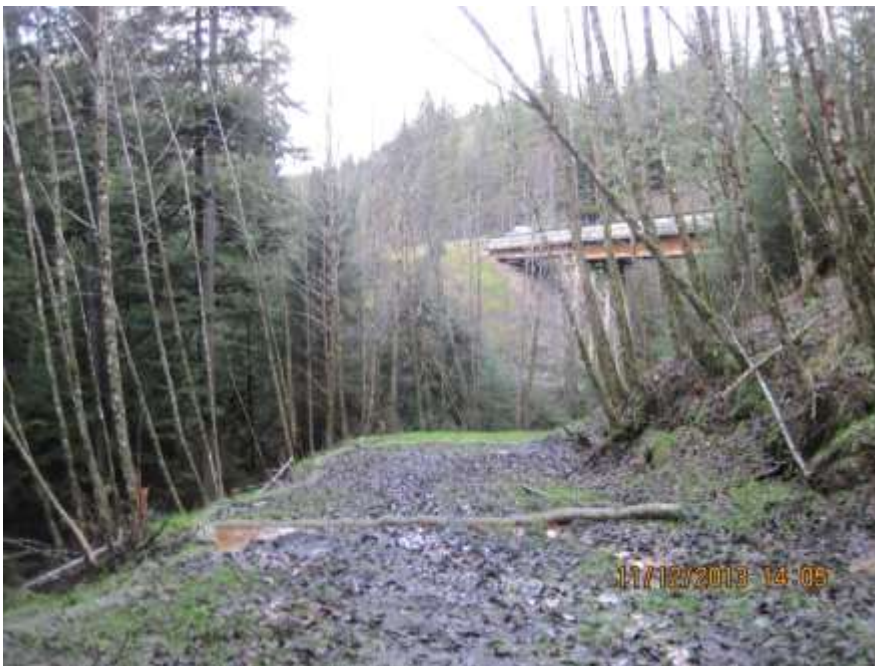
Stormwater runoff on the south side of the bridge was much reduced since the last inspection in September (photo 06).

Photo 06. Stormwater runoff on the south side of Zinc Creek Bridge has been greatly reduced since our last visit in September.

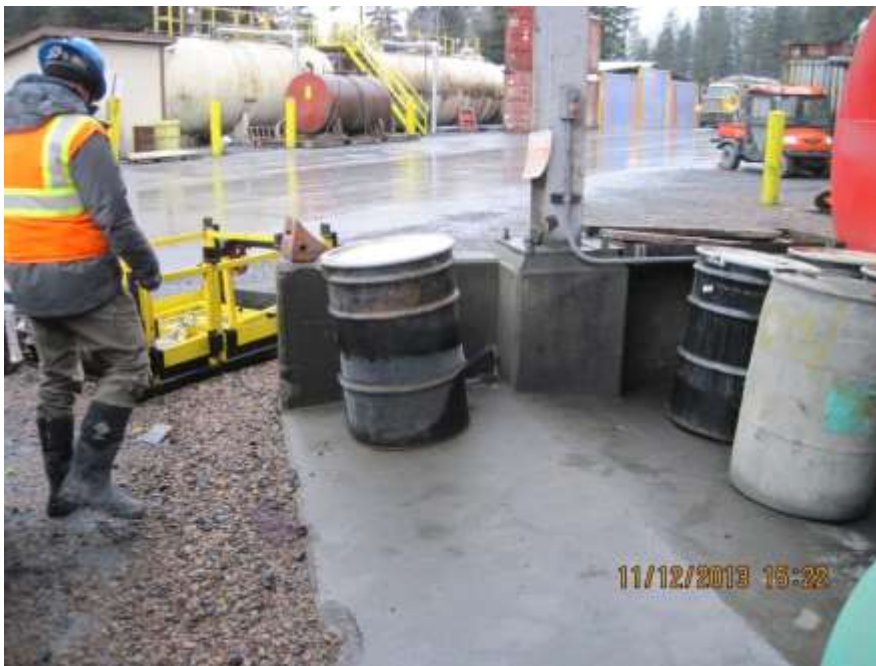
Photo 10. This drum of fuel waste was stored at the powerhouse without secondary containment.

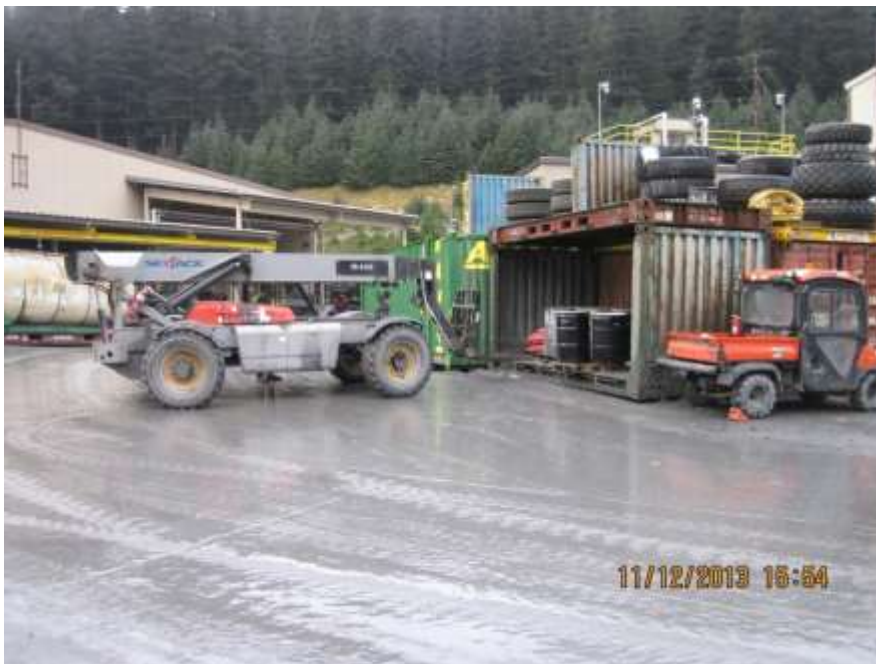
Photo 12. The drums and tote of used oil products were immediately moved.

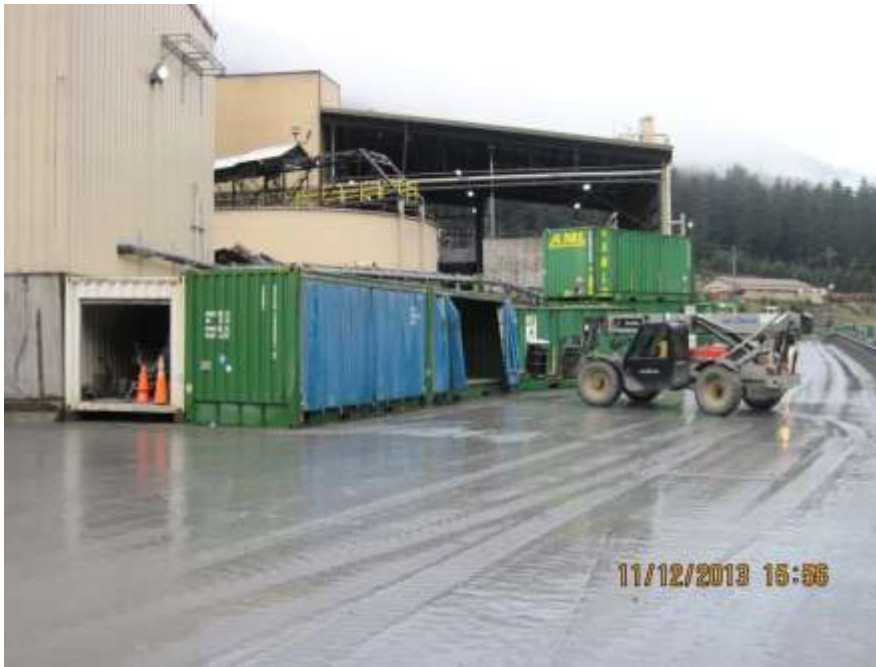
Photo 13. The drums and tote of used oil products were temporarily placed in this sea van. The sea van is on a concrete surface that drains to Pond A.
